**Use of Geotextiles with Enhanced Lateral Drainage in roads over
expansive clays**

May 2015

Eight test sections with different geotextiles were constructed on State Highway 21 in Bastrop, Texas. The road is founded on expansive clays. A number of geotextiles, including one with enhanced lateral drainage capabilities, were incorporated to 500 feet long test sections. All sections were equipped with sensors to monitor moisture beneath the

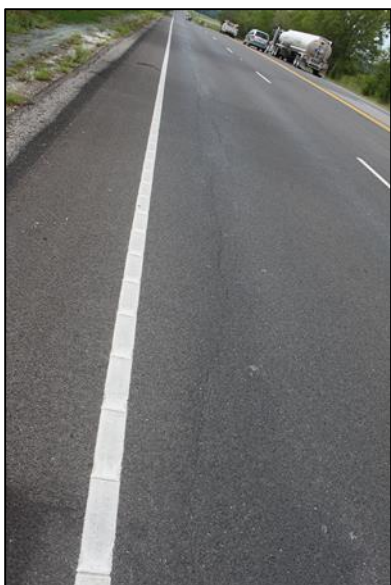
Figure 5.2: Example of Wheel Path Cracks in Section 8

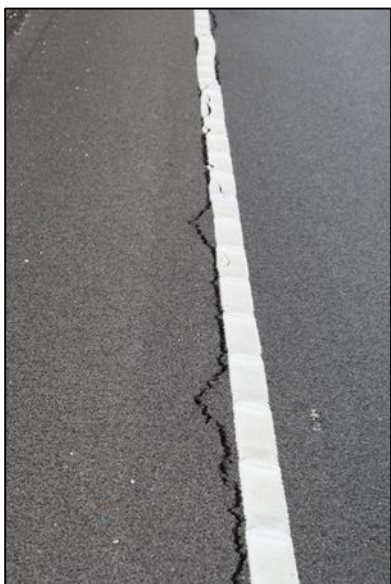
Figure 5.3: Example of Edge Crack in Section 7

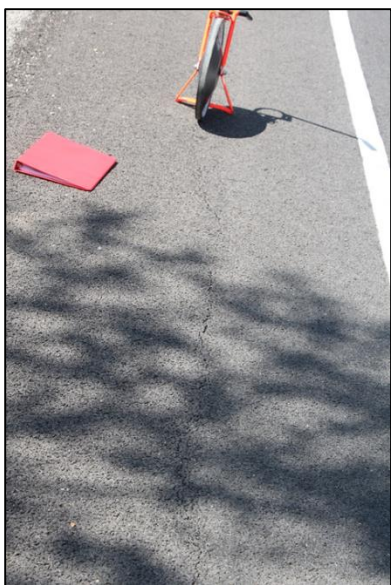
Figure 5.4: Example of Shoulder Crack in Section 6

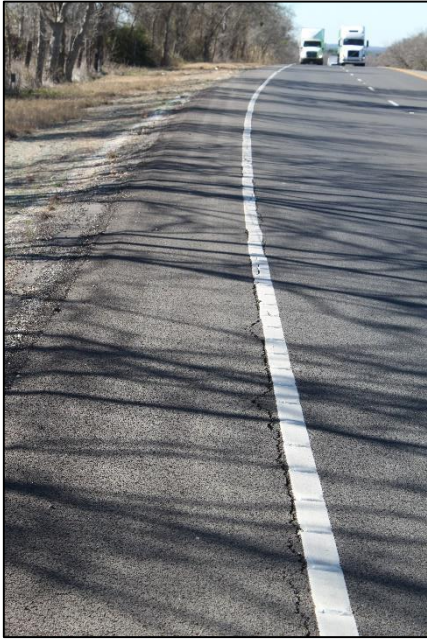
Based on this definition of shoulder cracks, the surveys showed that Section 4 and 7, both with GT4 installed, showed no shoulder cracking. These results may suggest that the GT4 geotextile may be causing the paved shoulder, built above the geotextile, to be displaced vertically as a single mass. The moisture data for these sections, discussed in Chapter 4, shows GT4 promoting a uniform moisture beneath it. This uniform moisture content beneath GT4 would result in the soils in this area expanding or contracting the same amount. The paved shoulder built above GT4 in this case, will move up and down all together and not experience differential movements which would possibly result in no longitudinal cracking in the shoulder area as the survey data shows. Figure 5.12 and Figure 5.13 show pictures taken of the shoulder areas of both Section 7 and 4 during the survey done on January 27, 2015. Both images show no cracking in what was defined as the shoulder area. Results appear to suggest that GT4 is able to prevent cracking in the shoulder, by equilibrating moisture beneath the geotextile through enhanced lateral drainage.

Figure 5.12: Shoulder area of Section 7 in January 27, 2015 Survey

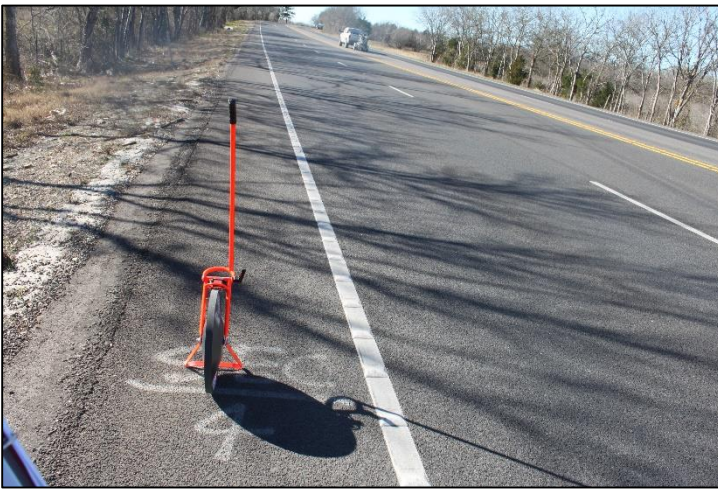
Figure 5.13: Shoulder area of Section 4 in January 27, 2015 Survey

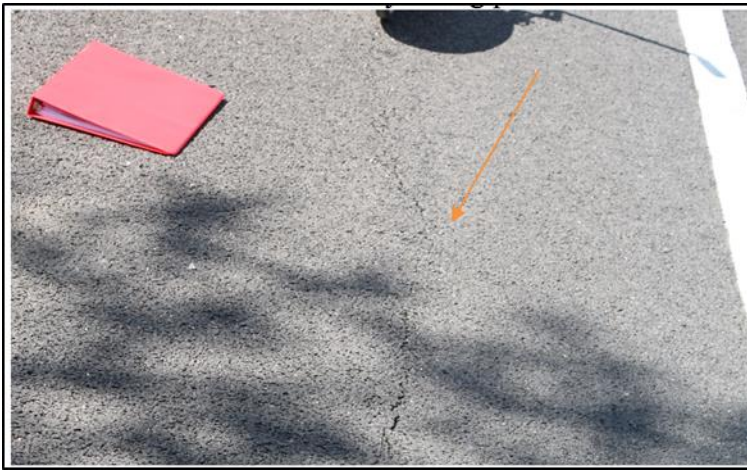
Sections 2 and 6 have GT3 installed which like GT2 provides soil reinforcement but has a higher tensile modulus as discussed in 4.3. Section 2, like Section 3, did not show any shoulder cracking. Section 6 showed cracking in the shoulder area at the beginning of the section as showed in Figure 5.16, which connects to the shoulder crack in Section 5. Unlike the crack in Section 5, the portion of it in Section 6 has been wider than 3 mm. Figure 5.15 shows the data from the condition surveys done in Section 6 which show cracking in the shoulder which is most probably due to expansive clays since the crack appears to close after various rain events.

Figure 5.16: Shoulder Crack at the beginning of Section 6

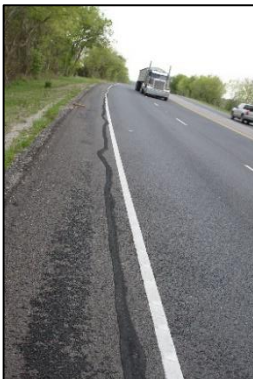
As described above, edge cracks are defined for the purpose of this study as cracks that are within 1 foot of the white line at the outer edge of the outer lane as shown in Figure 5.1 and Figure 5.17. This type of crack was the one most observed during the surveys, appearing the earliest. Figure 5.18 shows the progression with time of the edge cracks documented in all 8 test sections plotted together with daily precipitation and accumulative precipitation. Before going into the discussion, survey data until January 27, 2015 was used due to TxDOT sealing the cracks between this date and March 26, 2015. Figure 5.17 shows an example of one of the cracks sealed by TxDOT at some point between January 27 and March 26, 2015.

Figure 5.17: Image taken in Section 7 on March 27, 2015

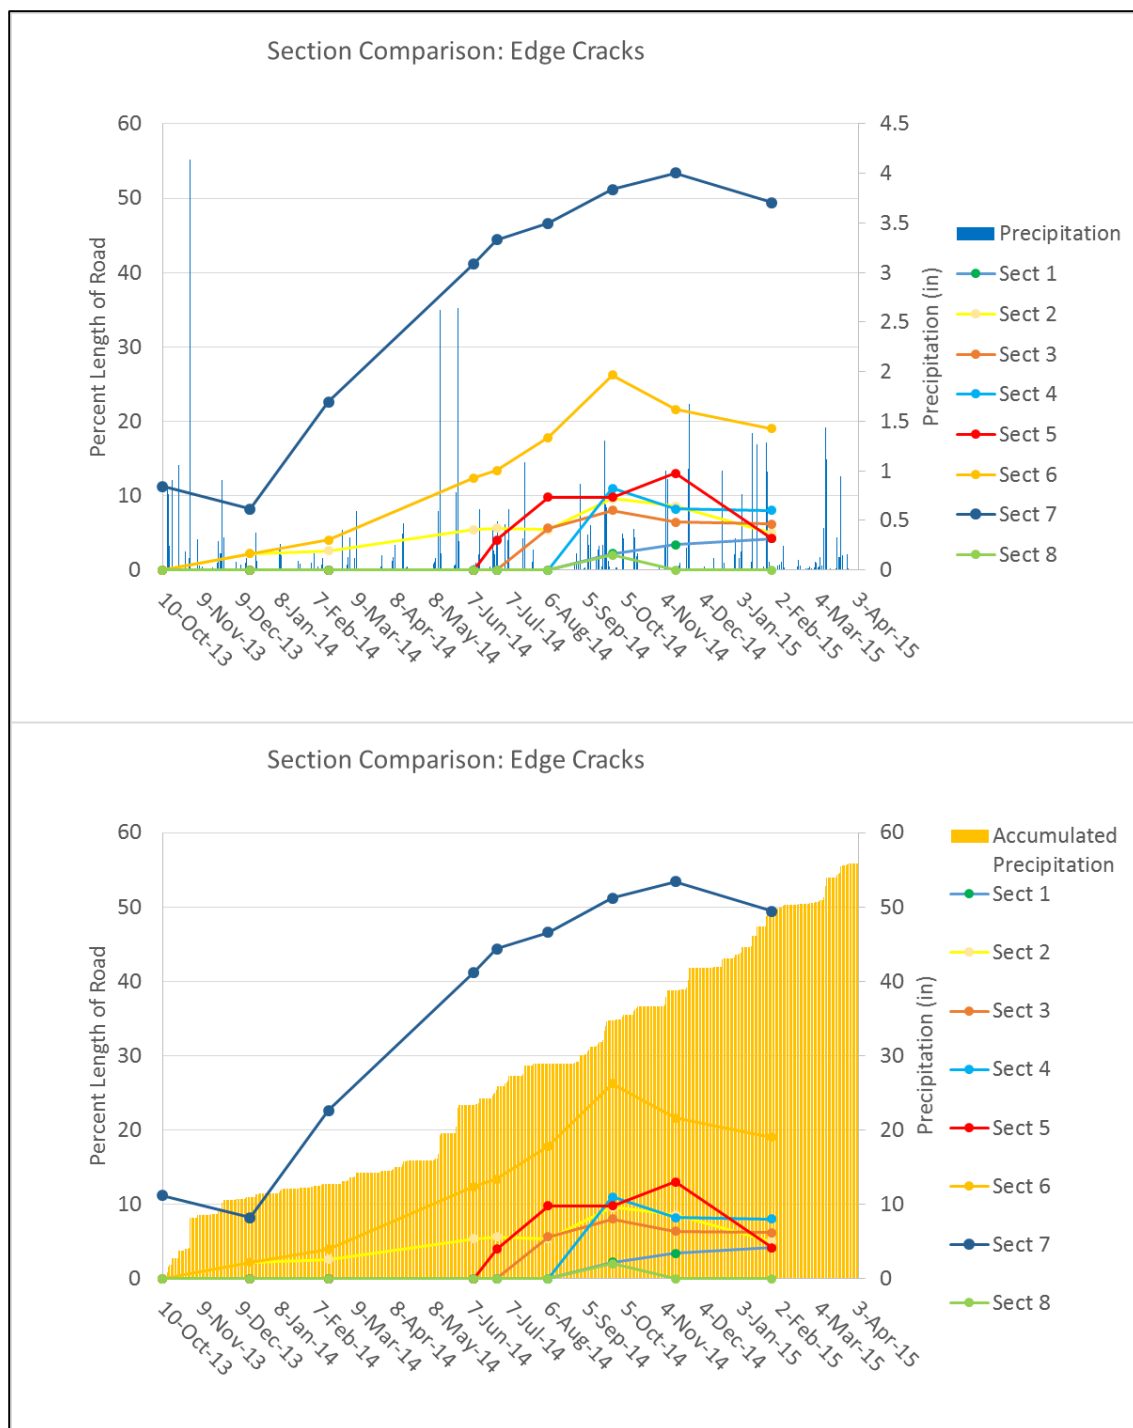
From the figures it can be said that Section 7 shows the highest number of edge cracks. This section was studied more carefully because the tendency of cracks due to expansive clays is that they will open during dry periods and close during wet periods. For Section 7 the progression of the cracks appeared to be unrelated to weather events suggesting another cause for the cracks. Figure 5.19 shows 2 images taken during a survey performed on November 13, 2014. These pictures show how the crack progresses perfectly parallel to the white line where the geotextile ends as shown in Figure 5.1. There is some vertical displacement evident also which could be due to consolidation of the new shoulder structure.

Figure 5.18: Comparison of Edge Cracks in each section over time

Some parts of the edge cracks in Section 7, could be due to expansive clays as well as data from condition surveys may suggest. There is a reduction in percentage cracking between October 10 and December 17, 2013, for which a significant amount of rain fell in Bastrop, Texas. This reduction in cracking could be due to human error while doing the condition surveys or that there was a portion of the cracking due to expansive clays which may have expanded and closed the cracks. Something similar was observed between November 13, 2014 and January 27, 2015 as shown in Figure 5.18.

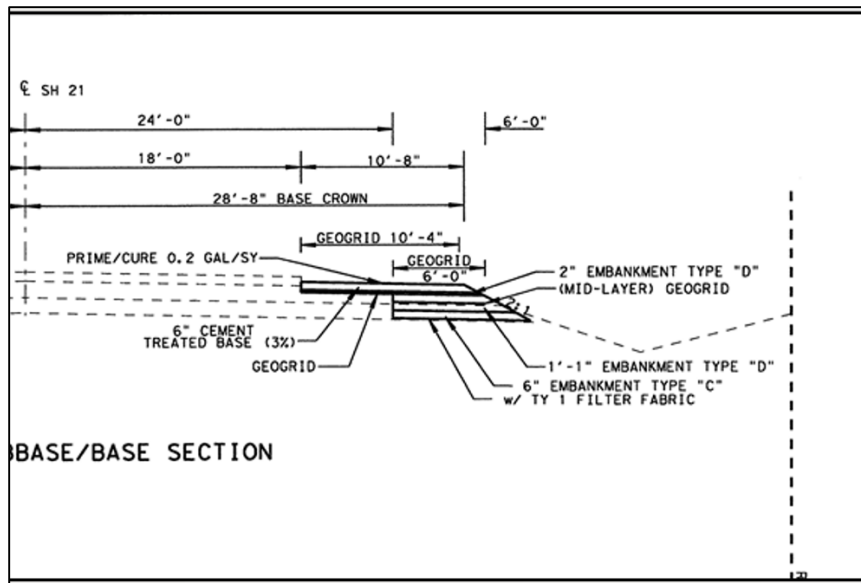
Figure 5.20: Pavement section from design plans for SH-21, Bastrop, Texas

These edge cracks in Section 7 are probably due to the discontinuity that takes place below the white line, where the GT4 geotextile ends and the old pavement structure starts as shown in Figure 5.20. This cracking is to be expected where the geotextile ends. In addition, the shoulder which is a new structure can be settling which could explain the vertical displacement observed in the image on the right in Figure 5.19. One more possibility is that these cracks can be due to GT4 causing the shoulder to move vertically as a single mass with moisture variations in the soils beneath the geotextile. These longitudinal cracks along the white line could be due to shear generated as the shoulder moves vertically suggesting GT4 is performing as expected and leading to uniform vertical movements beneath it.

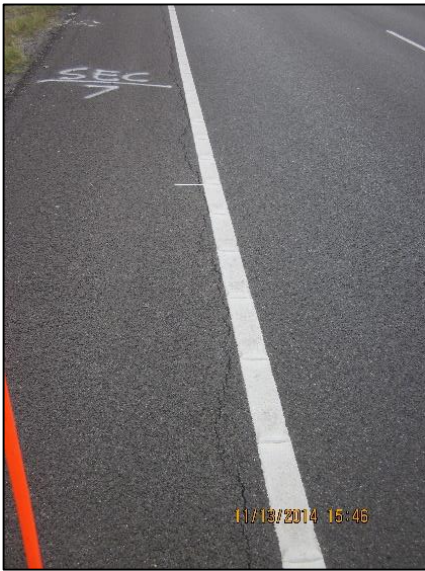
Section 6 which has GT3 installed, has shown some significant edge cracking as well. This section like Section 7, has progression of cracks that appear to be independent of rain events, which could suggest a situation similar to that of Section 7. This idea is reinforced by photos taken from the last surveys that show the edge crack from Section 7, progressing into Section 6 as shown below in Figure 5.21.

Figure 5.21: Edge Crack from Section 7 progressing into Section 6

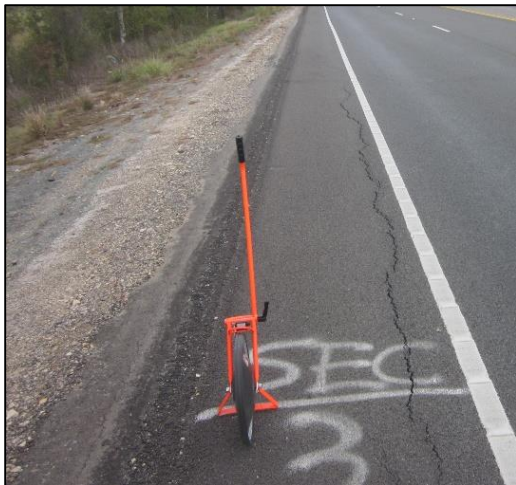
Section 3 has GT2 installed as its geotextile underneath the shoulder. This section has very similar cracking to Section 2, even though it starts showing cracks around 9 months later. There actually is an edge crack that continues from Section 2 into Section 3 as shown below in Figure 5.23. Similarly to Sections 2 and 4, the cracking percentage peaks on the survey performed on September 25, 2014, and decreases after this date, possibly due to various significant rain events happening before the surveys were done as shown in Figure 5.18.

Figure 5.23: Edge crack in Section 3

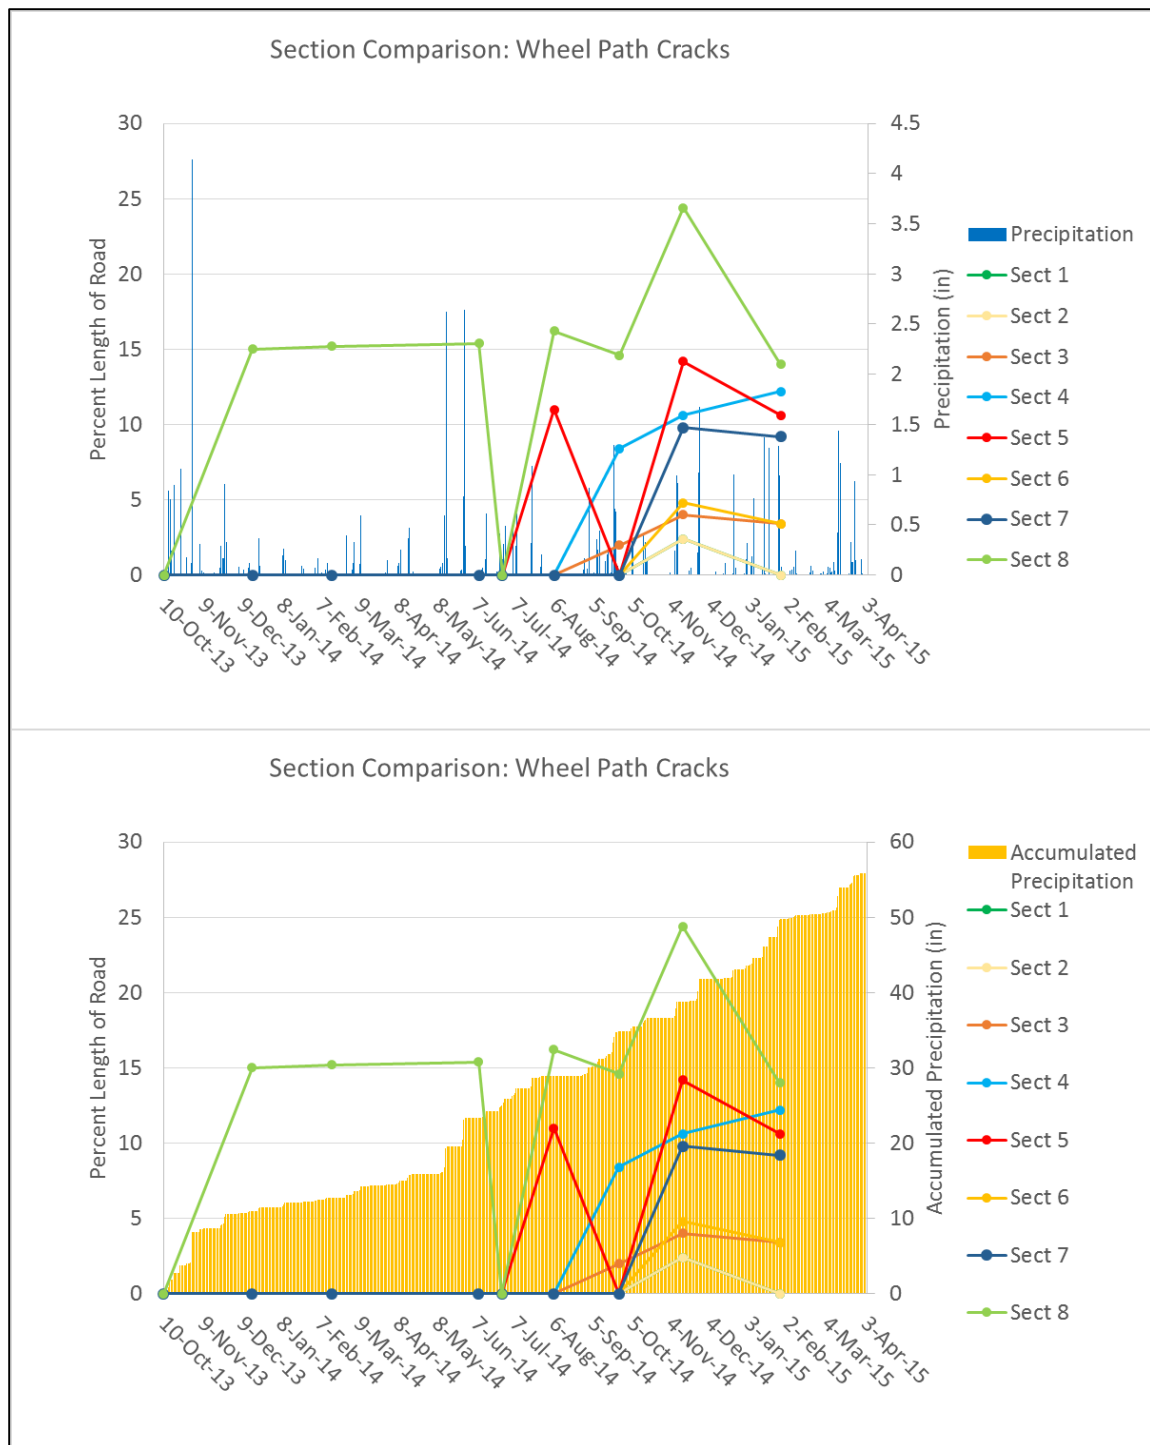
Figure 5.24: Comparison of Longitudinal Cracks in each section over time

Sections 4 and 7, which both are GT4 sections, showed very similar wheel path cracking. Section 4 cracks sometime between August 8 and September 25, 2014 during which there was a significant dry period. Section 7 cracks sometime between September 25 and November 13, 2014 for which, there was another dry period that lasted almost a month and a half. Figure 5.26 and Figure 5.27 show the data from the surveys for both sections, since the cracking percentage is not very high Figure 5.24 may show a clearer picture with the larger scale.

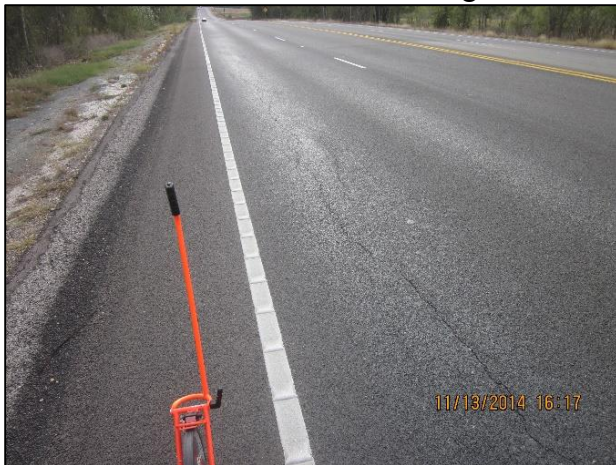
Figure 5.24 shows the progression of wheel path cracks in all 8 test sections plotted against time together with daily precipitation, and accumulated precipitation. Unlike edge cracks, Section 8 did have significant wheel path cracks. This section has installed GT1 which only serves for separation and provided some lateral drainage. The section showed rapid cracking between October 10 and December 17, 2013, going from 0 to 15% longitudinal cracking after which cracking did not increase much over time. On the fifth survey on June 27, 2014, the longitudinal cracks appeared to have all closed up due to various significant rain events and then are open again during the 6th survey on August 8, 2014. There was a dry period approximately during the two weeks previous to the August 8, 2014 survey, suggesting that the cracks closed up after the rain events and opening back up after 2 weeks of no rain. This would confirm that these cracks are due to expansive clays which obviously are present in this section with samples tested from this section having a PI of 58. The increase and decrease of cracking percentage shown in Figure 5.24 after the survey done on August 8, 2014 shows how the cracks open and close with relation to rain events. Figure 5.25 shows how extensive the longitudinal cracking is in Section 8, reaching almost 25% of the entire section length on November 13, 2014.

Figure 5.25: Wheel path cracks in Section 8

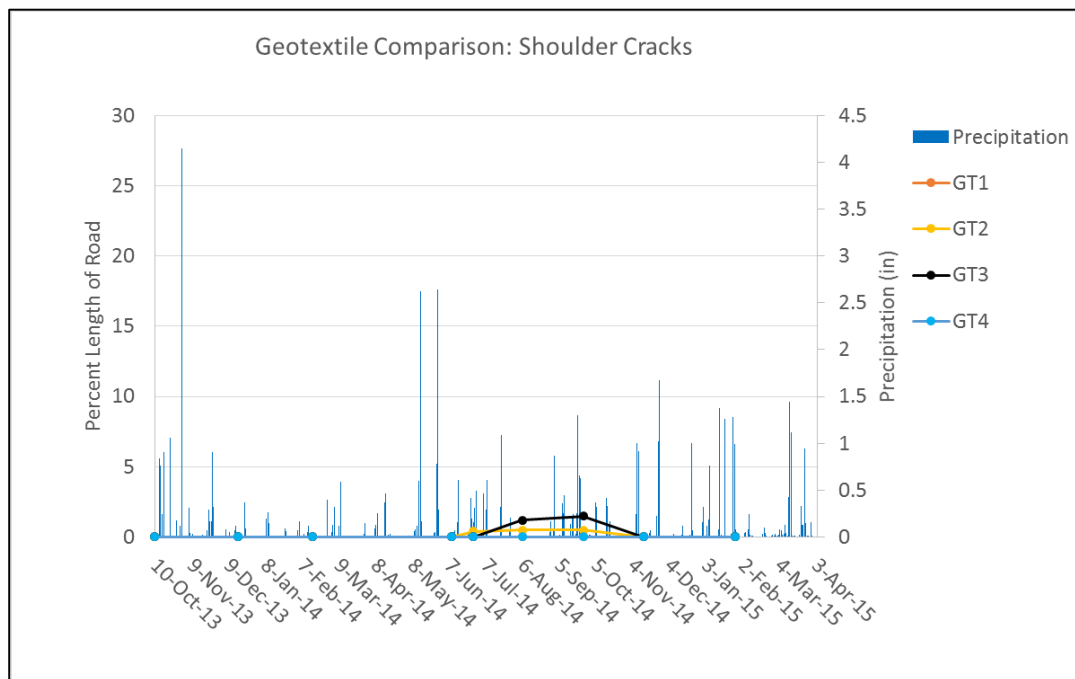
GT4 showed the least cracking in terms of shoulder cracking with none at all. The only two sections at the moment showing some shoulder cracking are Sections 5 and 6 which have installed GT2 and GT3. This suggest that GT4 may be causing the shoulder to move vertically as a single mass thus preventing bending stresses in the asphalt in the shoulder above GT4 as was expected. Figure 5.28 shows the data for shoulder cracking until the writing of this report, these cracks will most probably only grow with time and possibly provide more insight on the performance of the geotextiles in these expansive soils.

Figure 5.28: Comparison of Geotextiles in terms of Shoulder Cracking

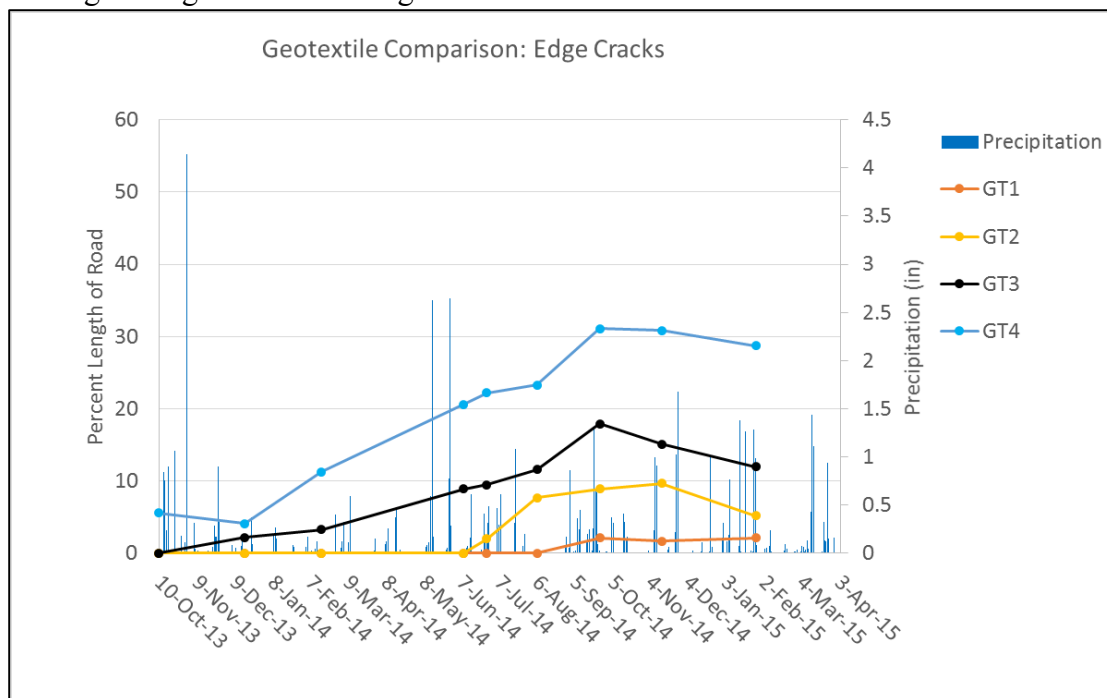
In terms of edge cracking, Figure 5.29 suggest that GT4 has the most edge cracking, which is not necessarily bad. This average is mostly due to the large amount of cracking in Section 7, which as explained previously is believed to be driven by factors related to the boundary condition where the geotextile ends and the old pavement structure starts as shown in Figure 5.1. The fact that all the edge cracking in Section 7 is concentrated along the white line where the geotextile ends, suggest the edge cracks may not be related to expansive clays and as previously mentioned, cracking at the end of the geotextile is to be expected. This area is one that poor material compaction could have taken place which could explain the location of the crack perfectly above the boundary where the new structure ends and the old one starts. One other idea mentioned above is that these cracks which are prevalent in GT4 sections, could be due to shearing from the shoulders moving vertically as a single mass as data seems to suggest. So the fact that the GT4 sections show the most edge cracks could possibly be a sign that the geotextile is performing as hoped for.

The two geotextiles which are capable of providing the most reinforcement from all the 4 geotextiles used in the study, showed edge cracking ranging from around 10 to 20 percent. GT3 sections had more edge cracking than GT2 sections, even though GT3 is stronger. GT1 showed on average less edge cracking than all other geotextiles as shown in Figure 5.29. The main reason for this is that Section 8 for some reason which is still not understood very well, showed little to no edge cracking during the period of this study and Section 1 being founded on a slightly different subgrade performed better than the other sections.

Figure 5.29: Comparison of Geotextiles in terms of Edge Cracking

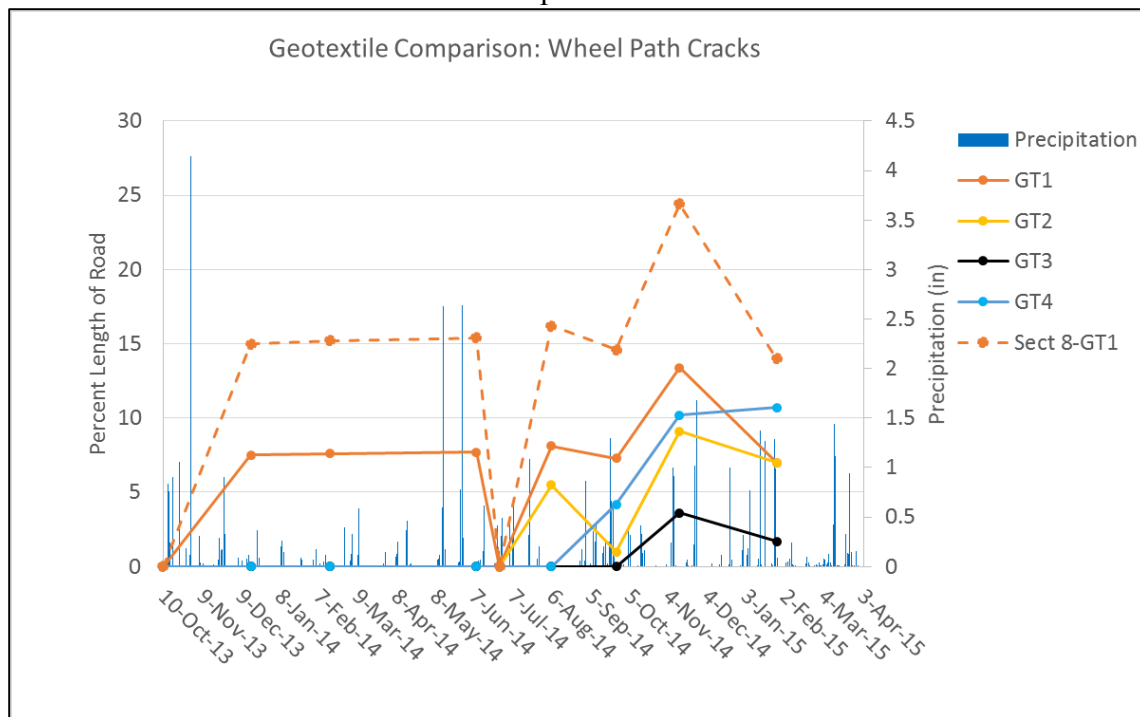
In terms of longitudinal cracking, Figure 5.30 suggests that the control geotextile, GT1, cracked the most. These results were to be expected taking into consideration that the GT1 only provides separation, while the other geotextiles are capable of providing reinforcement, confinement, and GT4 in particular has the enhanced lateral drainage capabilities.

The GT4 sections showed significant wheel path cracking as well, but as mentioned before, this could be due to GT4 performing as hoped. GT4 was installed only under the shoulder which data shows prevents longitudinal cracks within the shoulder but possibly not in the surrounding pavement. The shoulder will move up and down together as moisture in the soil changes but the outer lane, where the wheel path cracks developed, will not, thus generating shear stress and bending moments which can lead to the formation of the wheel path cracks. What these results show is that possibly this type of installation of GT4 is not adequate for pavements founded on expansive clays, the ideal case would be to have GT4 underneath the entire road and see how it performs then.

Figure 5.30: Comparison of Geotextiles in terms of Longitudinal Cracks

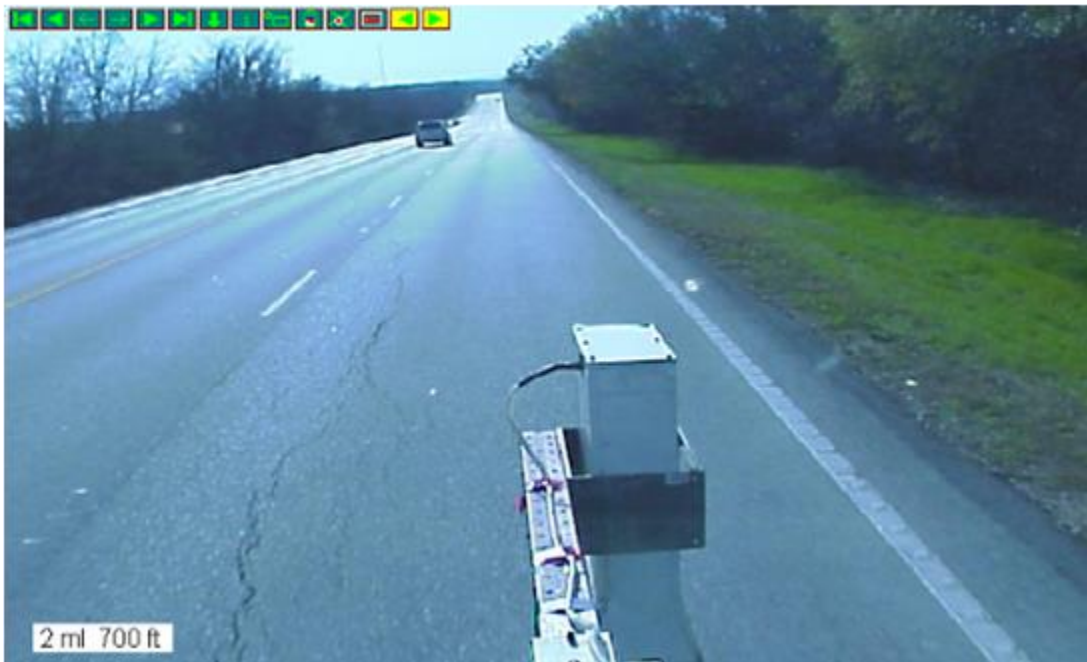
Figure A.5: Class 3 distresses in SH-21 (Texas Transportation Institute, 2010)

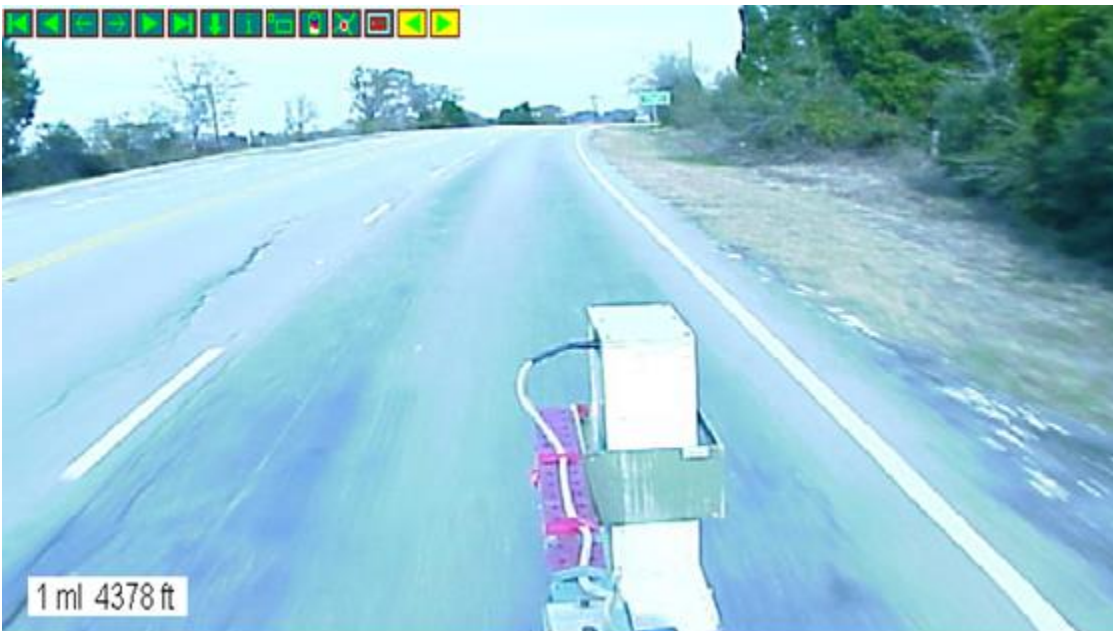
Figure A.6: Class 4 distresses in SH-21 (Texas Transportation Institute, 2010)
